FINAL REPORT

PARKERSON MILL CREEK RESTORATION FEASIBILITY STUDY

Submitted to Auburn University, Auburn, AL

Jennings Environmental, LLC
1400 Deboy Street, Raleigh, NC 27606

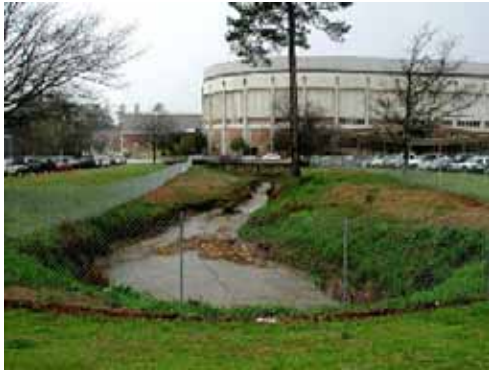
Reach A extends approximately 384 ft from a culvert crossing under Donahue Drive to a culvert crossing under Biggio Drive. The stream corridor is confined by Biggio Drive on the left side and a parking lot on the right side. There is a stormwater outfall entering the stream near the downstream end of Reach A. Future campus stormwater modifications call for increasing the size and relocating stormwater outfall upstream. Reach A is classified as an incised class F channel with a bank height ratio greater than 2 and very high bank erodibility. This reach is a high priority for stream restoration due to its instability and large contribution to downstream sedimentation. The proposed conceptual design is shown in Appendix A. There is sufficient room for excavation of a bankfull bench approximately 80 ft wide with a meandering class E channel approximately 24 square feet in bankfull dimension.

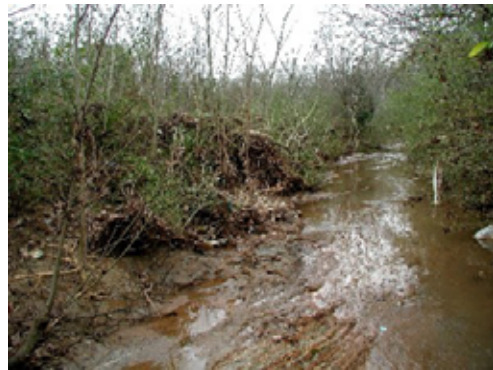
by a pasture. Reach P is classified as an incised class E channel with a bank height ratio between 1.4 and 1.8 and high bank erodibility. This reach is a high priority for stream restoration due to its instability and large contribution to downstream sedimentation. The proposed conceptual design is shown in Appendix A. Two cross sections were measured in riffles and one in a pool. There is sufficient room for excavation of a bankfull bench 150 ft wide with a meandering class E channel 85 square feet in bankfull dimension.

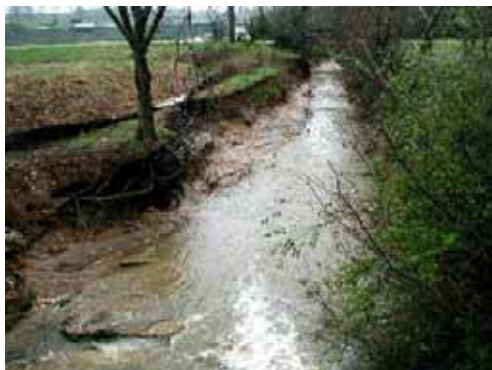
Reach C is downstream of Reach B, extending approximately 868 ft from a culvert crossing under West Samford Avenue to the confluence of Reaches C and E. The stream corridor is confined by athletic fields on the left side and Biggio Drive and parking lots on the right side. Reach C is classified as an incised class G channel with a bank height ratio greater than 2 and very high bank erodibility. This reach is a high priority for stream restoration due to its instability and large contribution to downstream sedimentation. The proposed conceptual design is shown in Appendix A. There is sufficient room for excavation of a bankfull bench approximately 100 ft wide with a meandering class E channel approximately 45 square feet in bankfull dimension. There is a foot bridge in this reach that may limit full implementation of this design if it is not removed or replaced.

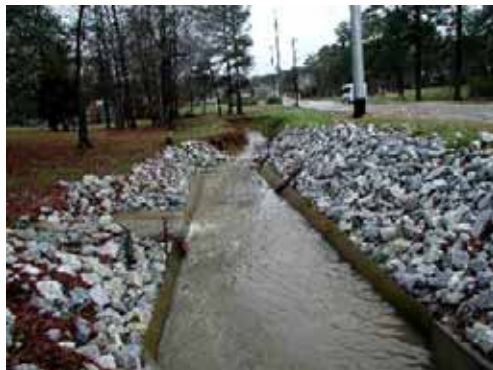
Reach I is upstream of Reach H, extending approximately 573 ft from a culvert under Roosevelt Drive to the confluence of Reaches I and K. The stream corridor is confined by West Thatch Avenue on the right side. Reach I is classified as an incised class E channel with a bank height ratio of approximately 1.5 and high bank erodibility. This reach is a high priority for stream restoration due to its instability and moderate contribution to downstream sedimentation. The proposed conceptual design is shown in Appendix A. There is sufficient room for excavation of a bankfull bench approximately 60 ft wide with a meandering class E channel approximately 14 square feet in bankfull dimension.
